UNITED STATES ENVIRONMENTAL PROTECTION AGENCY
REGION 8

Re: Request for Information Pursuant to Section 308 of the Clean Water Act, 33 U.S.C. § 1318

Excerpt from the EPA's Inspection Report for CDOT's Municipal Separate Stormwater System

I-25 Post Rain Event Inspection. Northbound lane.**Aug 23, 2013**

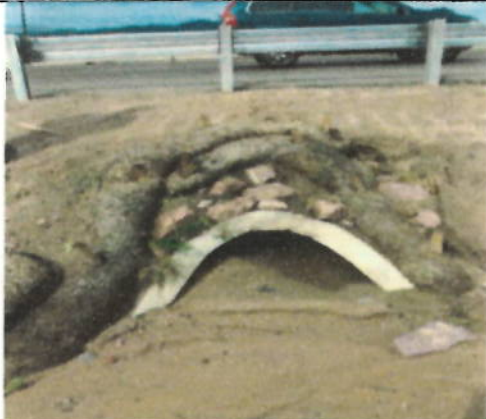
- Photos 1 and 2 in the August 23, 2013 inspection report show concrete culvert inlets that appear to be approximately 80-90% full with sediment, and the report noted that this was due to a lack of upstream BMPs. The report also stated for both photos 1 and 2, "Replace erosion logs around the inlet. Temporarily or permanently stabilize associated slopes discharging to the inlet. Add check dams to bare channels. Alternatively, add a compacted berm at the end of the channel with an excavated sediment trap at in front of it."

<p>Photo 1: Inlet near mm 149.61. Near Woodman. Sta. 976+00. Discharges to permanent detention basin to Pine Creek.</p>	<p>Photo 2: Inlet near mm 149.67. Sta. 976+25. Discharges to permanent detention basin to Pine Creek.</p>

Photo 1: Inlet filled with sediment due to lack of upstream BMP's. Inlet, cross drain, and large RCP running down the center median strip of I-25 must be cleaned and sediment disposed of properly. Replace the erosion logs around the inlet. Temporarily or permanently stabilize associated slopes discharging to the inlet. Add check dams to bare channels. Alternatively, add a compacted berm at the end of the channel with an excavated sediment trap at in front of it.

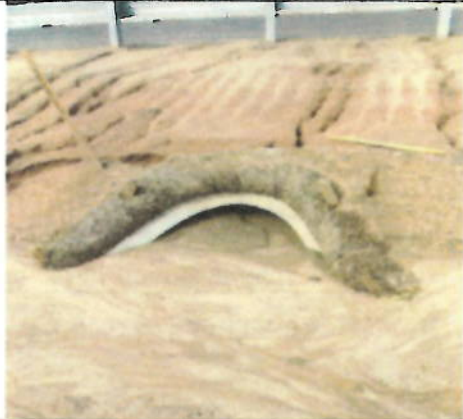
Photo 2: Inlet filled with sediment due to lack of upstream BMP's. Inlet, cross drain, and large RCP running down the center median strip of I-25 must be cleaned and sediment disposed of properly. Replace the erosion logs around the inlet. Temporarily or permanently stabilize associated slopes discharging to the inlet. Add check dams to bare channels. Alternatively, add a compacted berm at the end of the channel with an excavated sediment trap at in front of it.

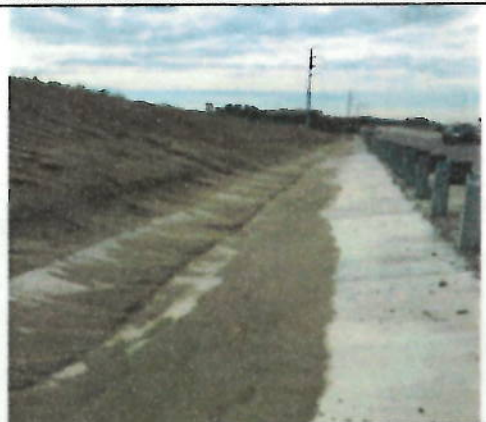
<p>Photo 3: Concrete channel mm 149-149.35. Discharges to Pine Creek.</p>	<p>Photo 4: Detention pond near end of project at Woodmen. Outfalls to Pine Creek.</p>

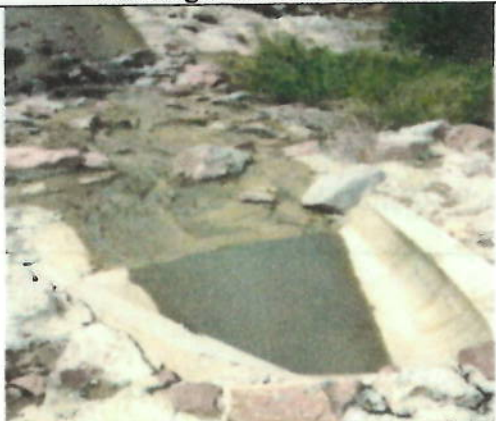
<p>Photo 5: Detention pond outfall to Pine Creek</p>	<p>Photo 6: Inlet at station 1138</p>

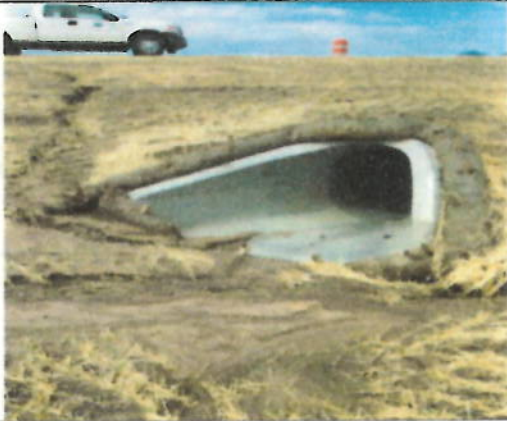
- Additional photos in the August 23, 2013 inspection report show similar inlets where a straw wattle in front of the inlet appears to have been overcome with sediment (photos 6, 7, 9, 10, 11, and 19) or there was no protection around the inlet (photos 15, 17, 24, and 25). A significant amount of erosion appears around some inlets, as evidenced by rills and other channels where erosion appears to have occurred (photos 2, 6, 9, 11, 19, and 25).

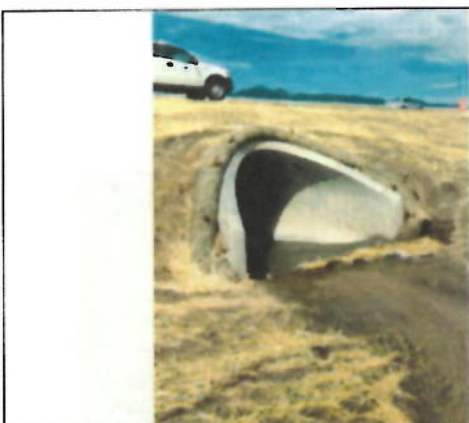
Photo 7: Inlet at station 1144

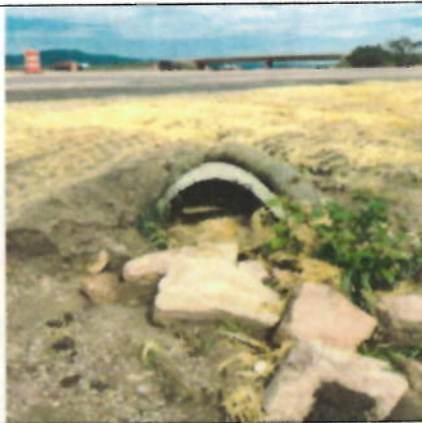
Photo 8: Outfall under exit 153 ramp

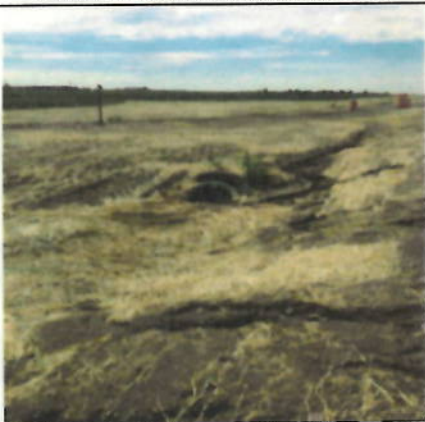
Photo 9: Inlet at exit 153 ramp

Photo 9: Inlet, cross drain, and RCP under the exit 153 ramp must be cleaned and sediment disposed of properly. Replace the erosion logs around the inlet.

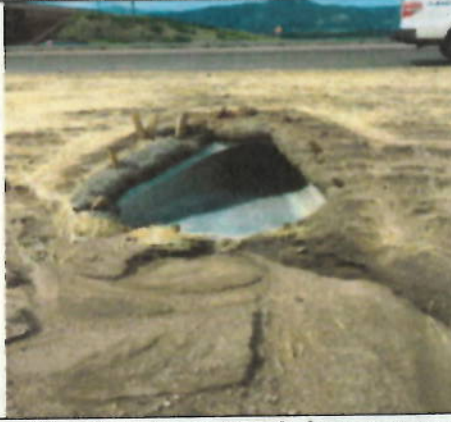
Photo 10: Inlet at mm 153.2, just past overpass

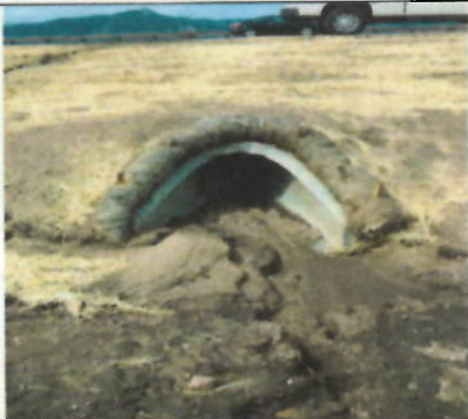
Photo 11: Inlet mm 153.35, near inactive hotel

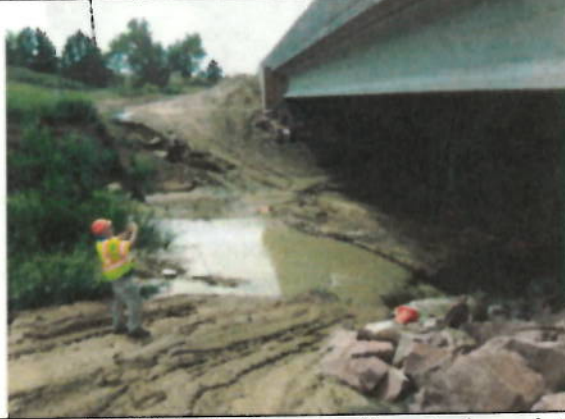
- Photos of creek crossings in the August 23, 2013 inspection report show a lack of BMPs in the area, rills on the hillsides above the creeks, and sediment plumes in the creeks (photos 12, 16, and 22). Creeks included Black Squirrel Creek at mile marker 154, Jackson Creek at mile marker 157.8, and Teachout Creek at mile marker 159.5. The report noted that each of these areas was covered under a 404 permit, a sediment plume was in the creek, and instructed consultation with the Army Corps of Engineers for direction on cleaning up the area and installing proper BMPs to prevent discharge.

Photo 12: Illicit discharge sediment plume into Black Squirrel Creek South at mm154, station 1218+50.

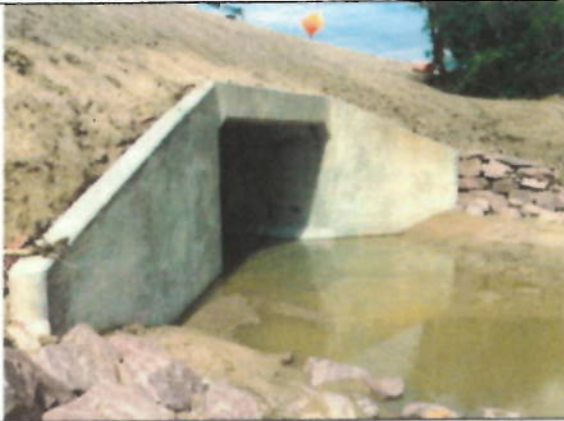
Photo 13: Illicit discharge into Black Squirrel Creek North at mm 154.3, sta. 1228+00.

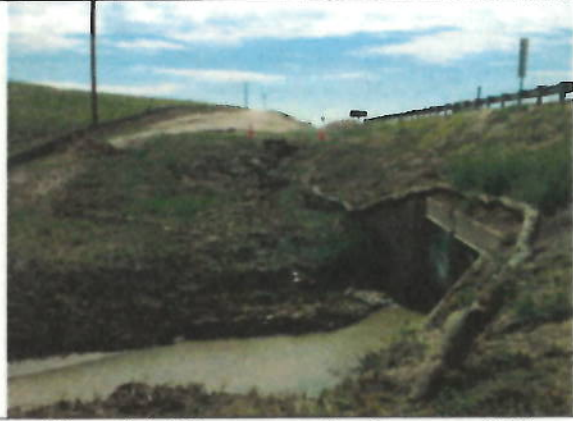
Photo 14: Monument Creek at mm 157.

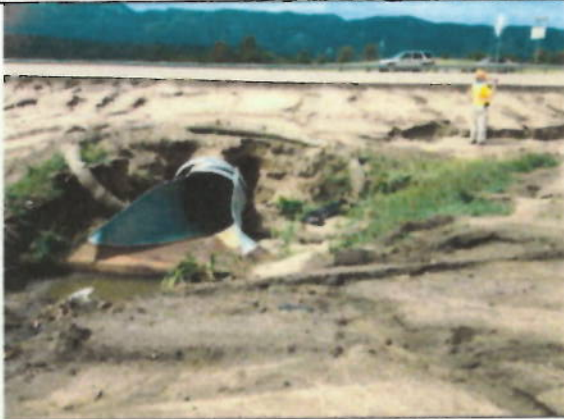
Photo 15: Inlet at mm 157.2

Photo 15: Backfill around the inlet with dirt. Replace the erosion logs around the inlet. Temporarily or permanently stabilize associated slopes discharging to the inlet. Add check dams to bare channels. Alternatively, add a compacted berm at the end of the channel with an excavated sediment trap at in front of it.

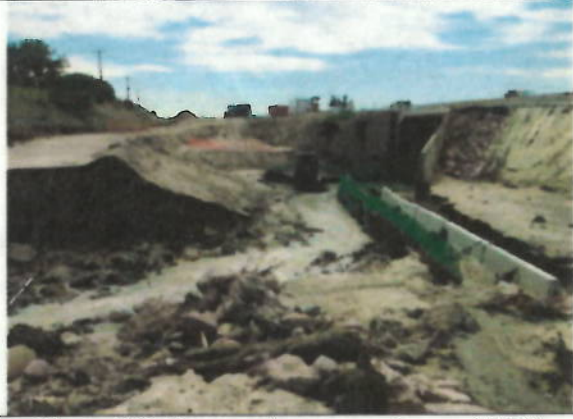
Photo 16: Beaver dam area at mm 157.8. Jackson Creek.

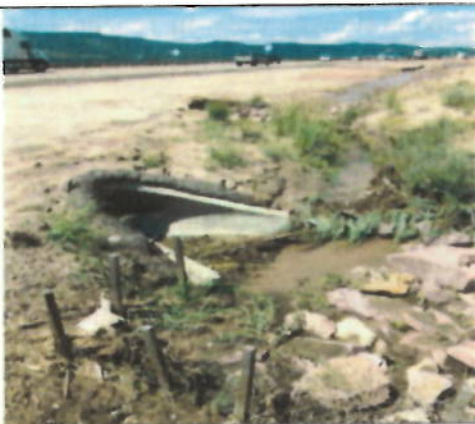
Photo 17: Inlet at mm 158.25

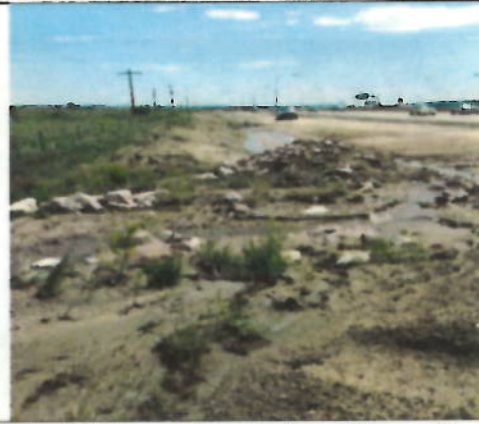
Photo 18: Run of water from Home Depot detention pond at mm 158.3

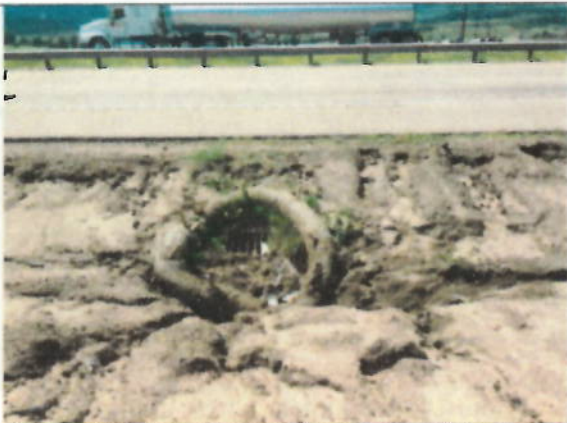
Photo 19: Inlet at mm 158.5

Photo 19: Remove sediment from around the inlet. Clean sediment out of the pipe apron. Replace erosion logs. Temporarily or permanently stabilize associated slopes discharging to the inlet. Add check dams to upstream bare channels. Alternatively, add a compacted berm at the end of the channel with an excavated sediment trap at in front of it.

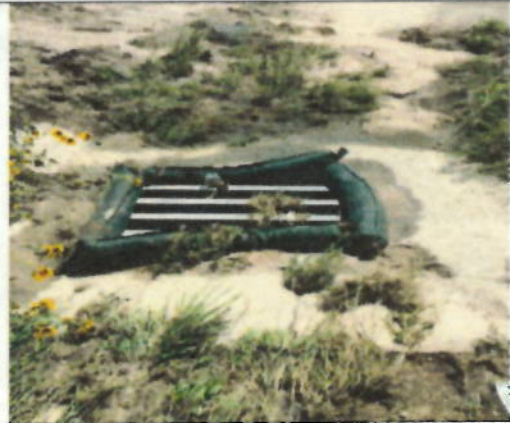
Photo 20: Inlet at mm 159 by Discount Tire

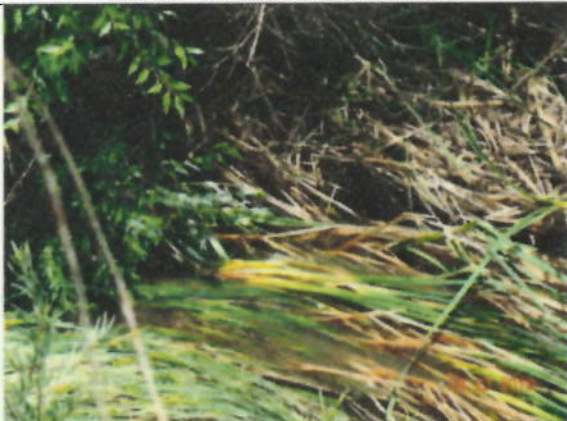
Photo 21: Clear water incoming to double RCP's at mm 159.5. Teachout Creek.

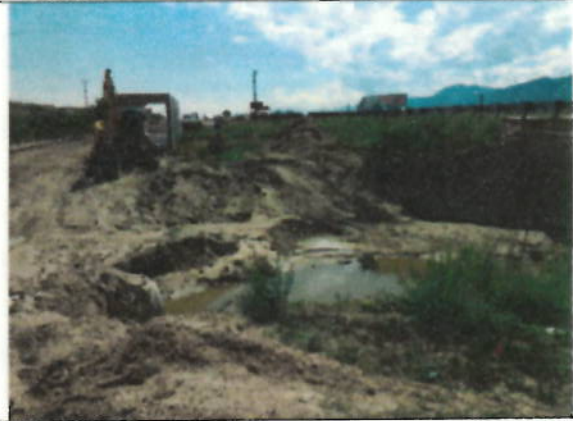
Photo 22: Illicit discharge on construction site after double RCP's at mm 159.5. Excavator worked in flowing water in Teachout Creek.

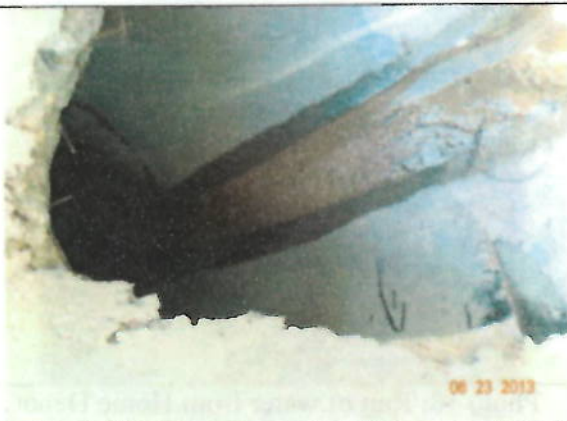
Photo 23: Pipe clean upstream of project, sediment in pipe downstream of project. Photo inside inlet at mm 159.7.

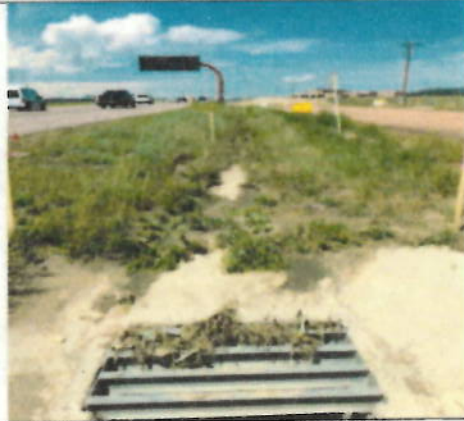
Photo 24: Photo of outside of inlet at mm 159.7

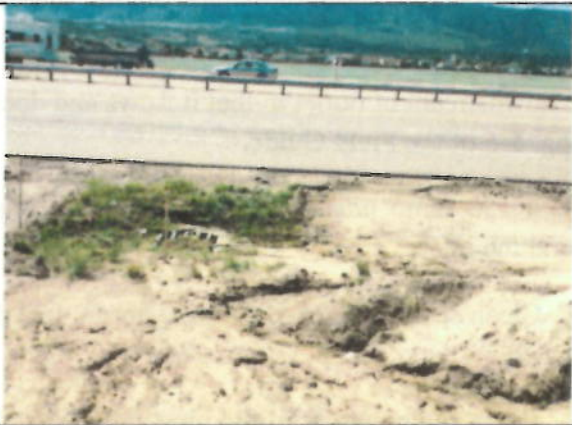
<p>Photo 25: Inlet at mm 159.8</p>	<p>Photo 26: Ditch from mm 159.7-160. A run of this length of disturbed ditch line and associated de-nuded slope is typically seen on this project with no BMP's, except erosion logs at the inlet.</p>
